Recent Tevatron Operations + Last Week's Failure in D3

Ron Moore

Fermilab – Tevatron Dept.

Component Failure in D3

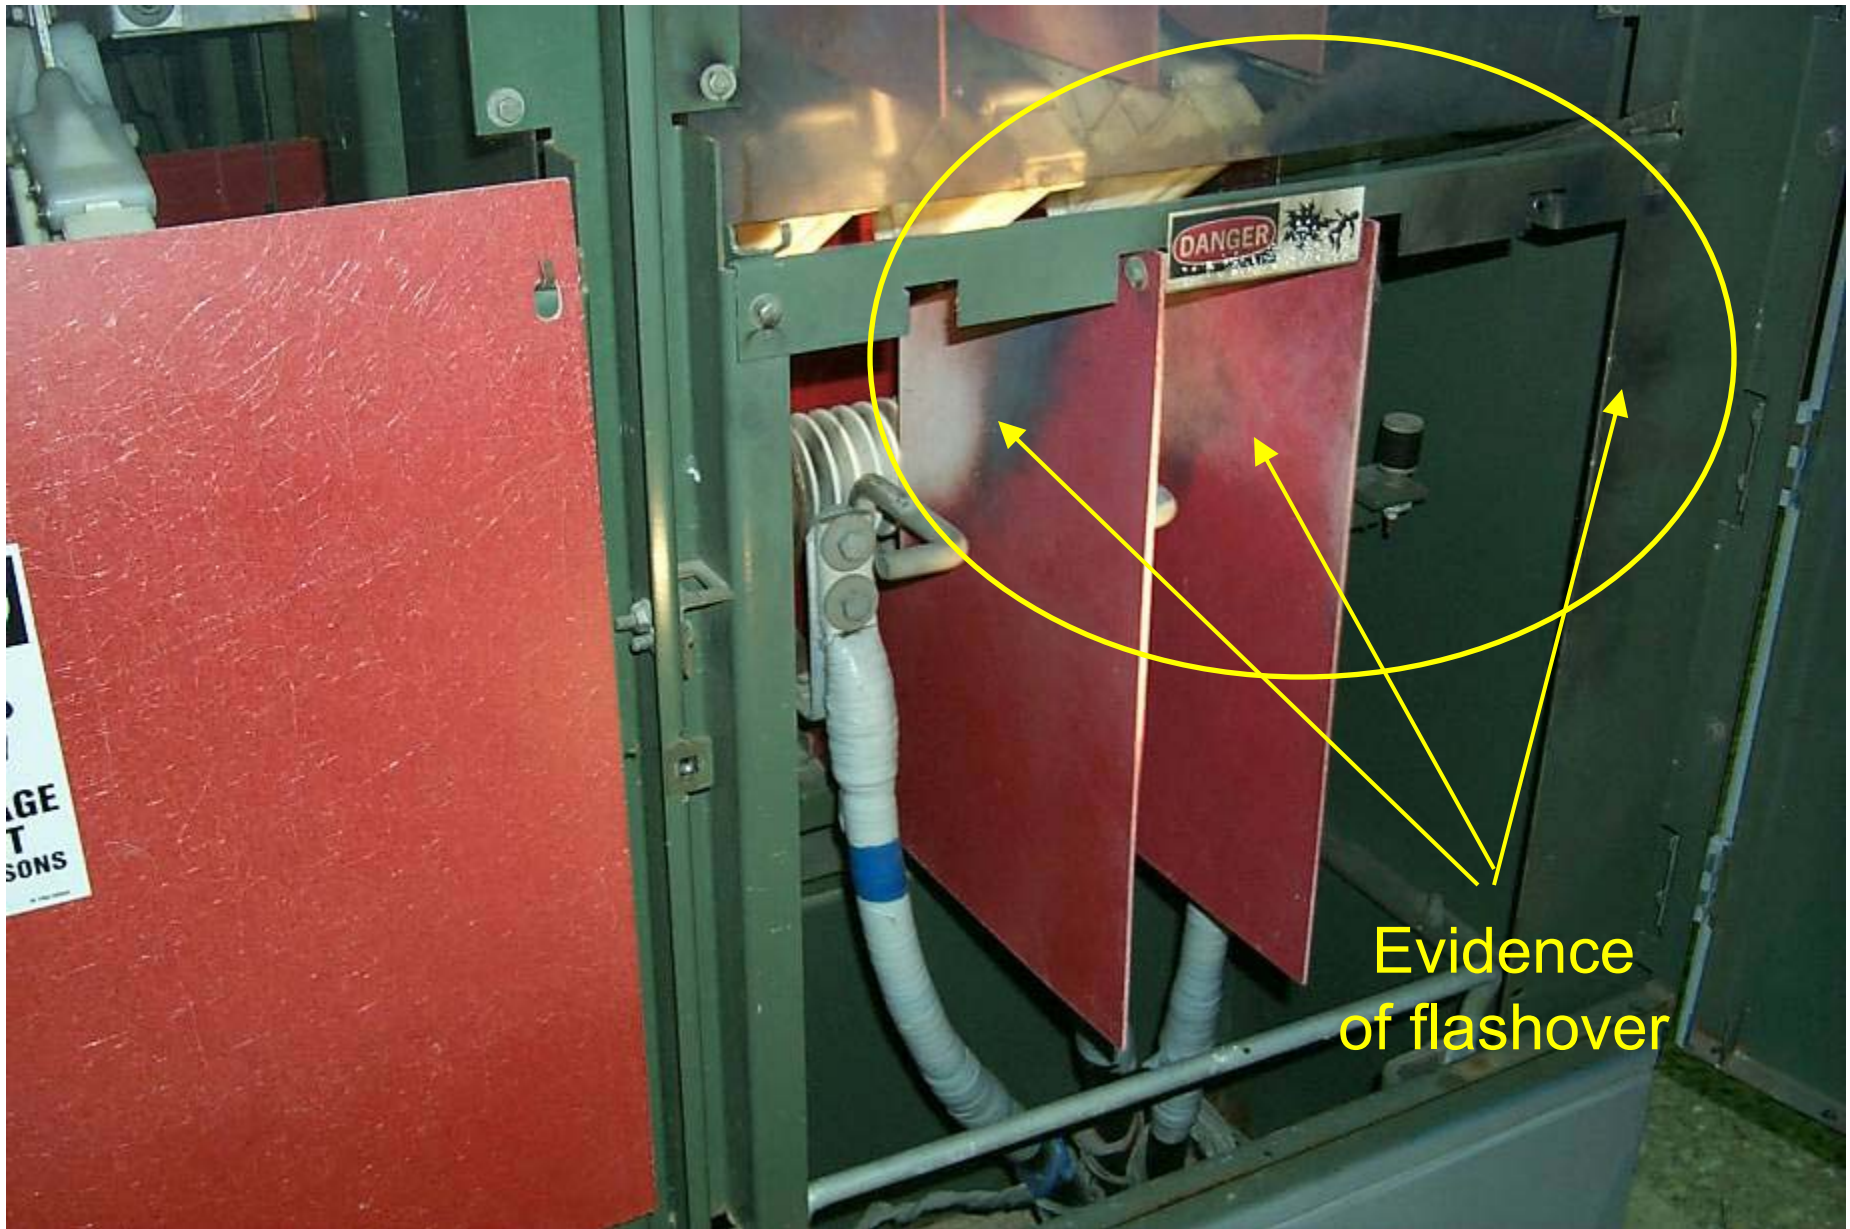
Feeder 46B Cubicle near D0

- HEP store 5008 happily spinning
 - Record # pbars injected into Tev, record # pbars reach HEP start
- Mouse seeks Feeder 46B cubicle as possible new, cozy home
 - Flashover + resulting nasty power glitch affects many systems
 - Many UPS units switched over
- Tevatron ramp begins to dump on A2 power supply trip
 - Beams aborted cleanly
- 1.2 sec into ramp dump, D3 QPM reboots (Quench Protection Monitor)
 - Why? Glitch not filtered out by UPS? UPS tested fine later...
 - As designed, QPM fired heaters, generating whole-house quench
- ≈ 4 sec into ramp dump, ground fault developed in D3
 - D32-5 dipole failed

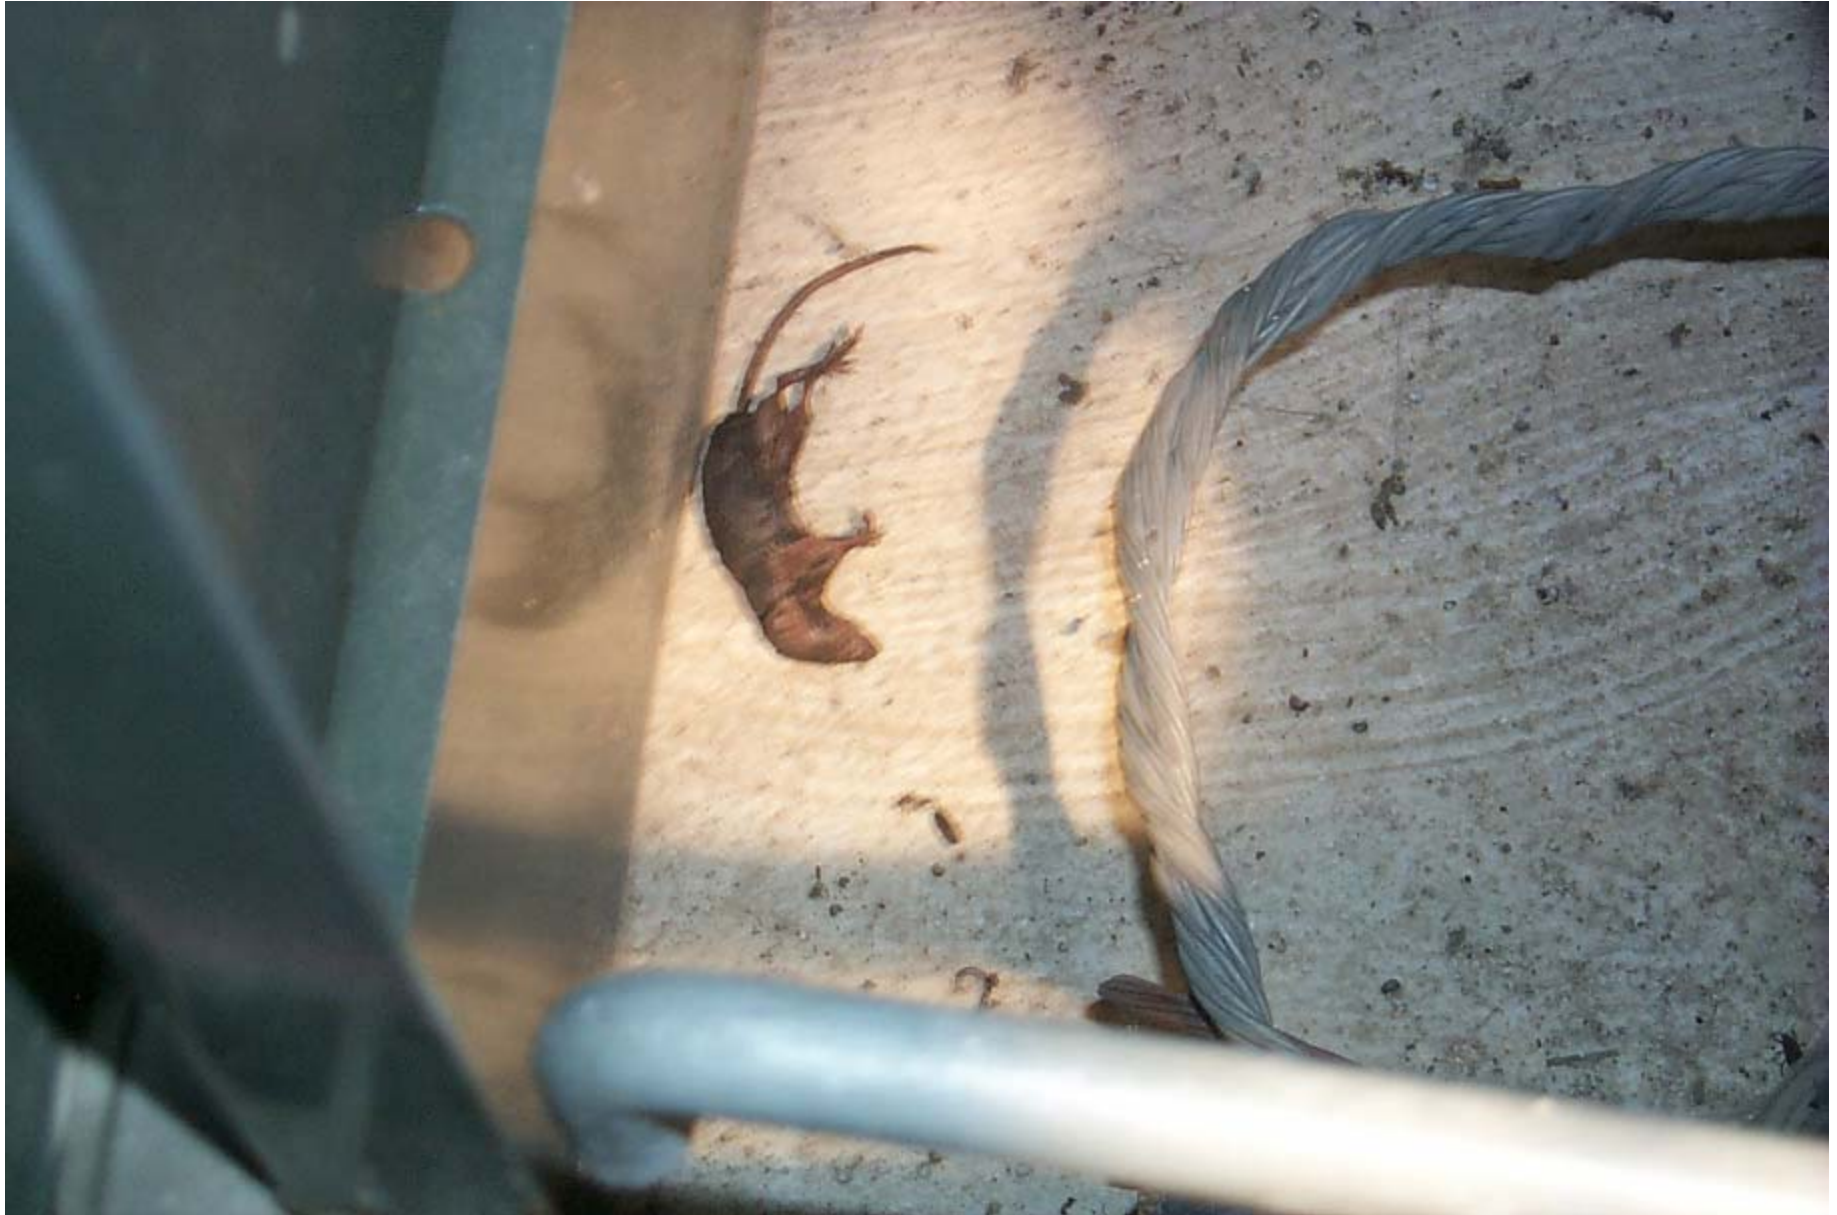
The Culprit

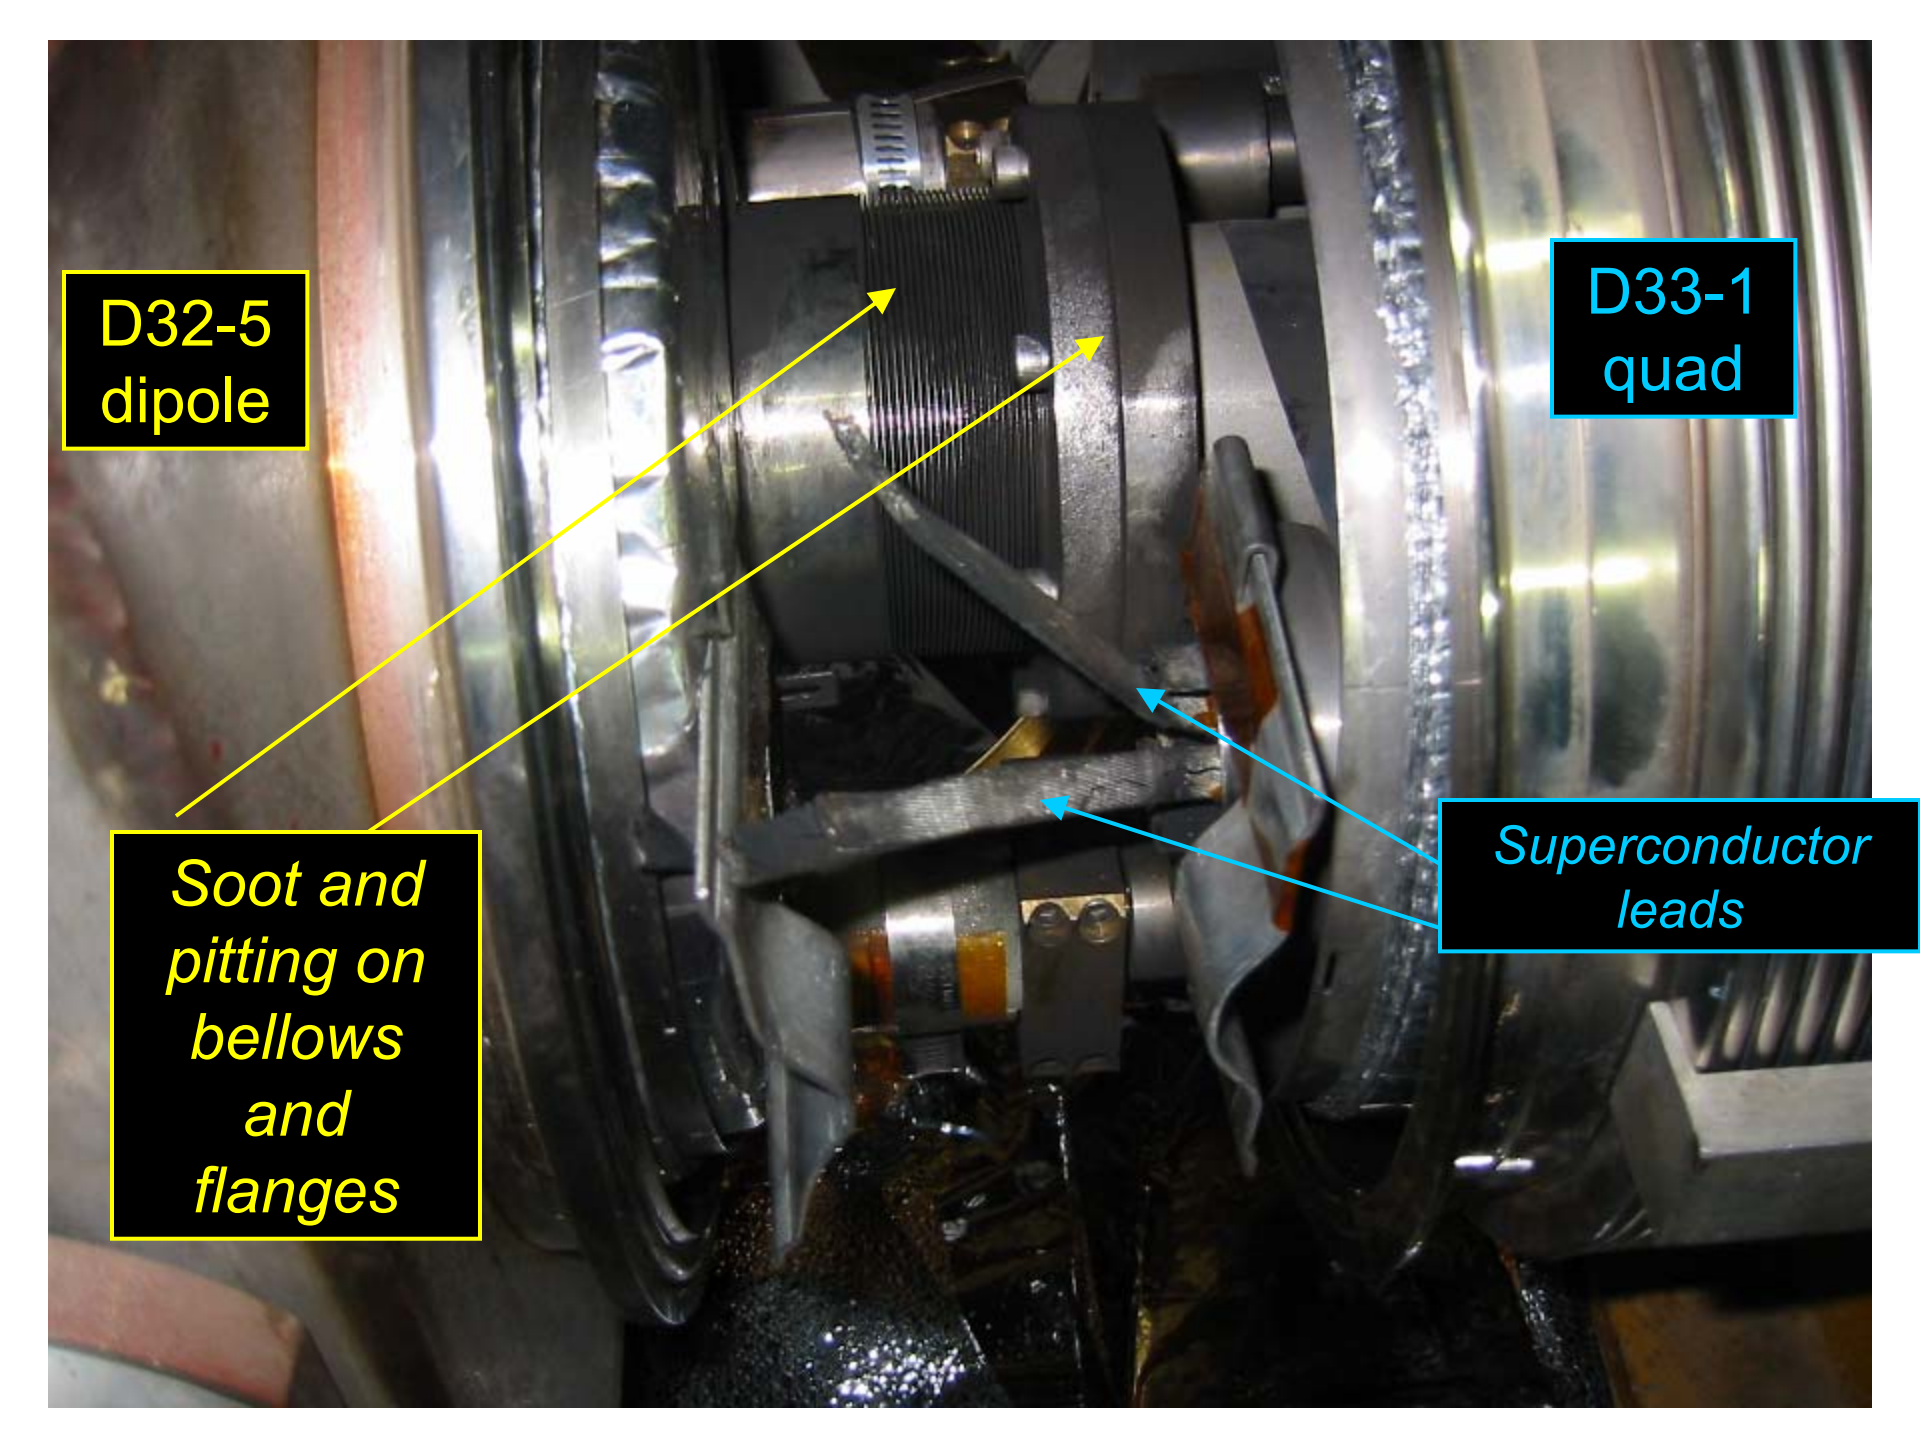
*Soot and
pitting on
bellows
and
flanges*

*Superconductor
leads*

- Why that failure now? Speculate that a problem was lurking there...
 - Mechanical stresses from this quench enough to cause failure
 - D3 quenches infrequent – last one was Sep 11, 2002
- What is being replaced?
 - D32-5 dipole and D33-1 quadrupole
 - D35 spool package (broken dipole corrector, unrelated to this failure)
- Helium and “soot” in beam tube
 - Sucked into beam pipe from single phase line after arc-through
 - Leaky isolation valves between adjacent sectors...D1-D2-D3-D4
 - Complicated vacuum recovery
 - Swabbed out $\geq 10(?)$ magnets – required moving into aisle
 - Concern about separators
 - RGA scans show plenty of helium, but little carbon or hydrocarbons
 - More optimistic now, still want to power them up soon to check
 - Will need time for conditioning, can be done during cool-down

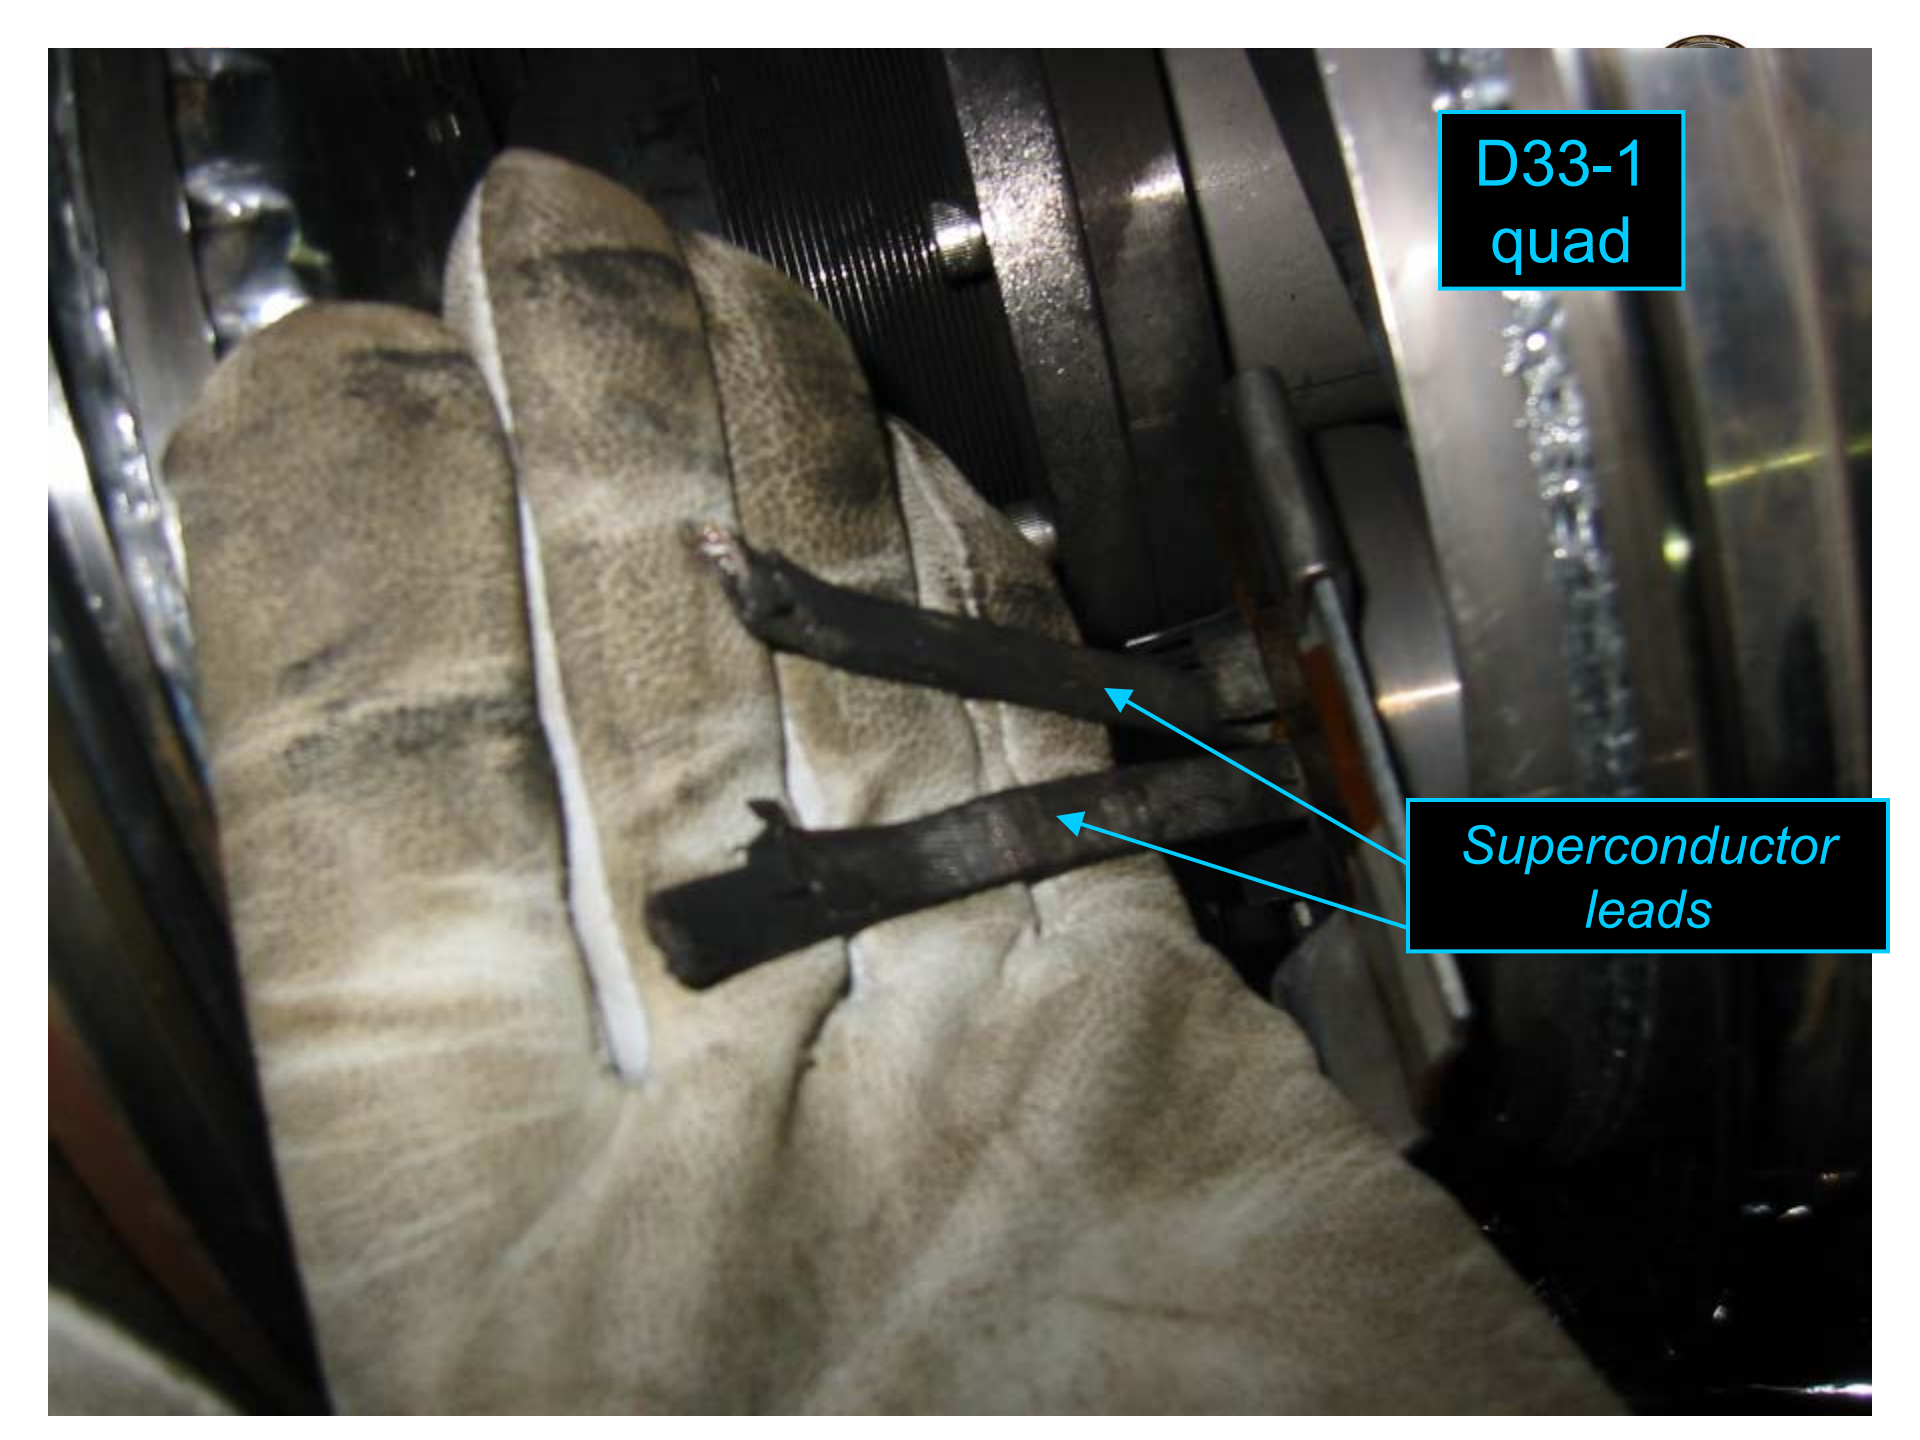
D33-1
quad

*Superconductor
leads*

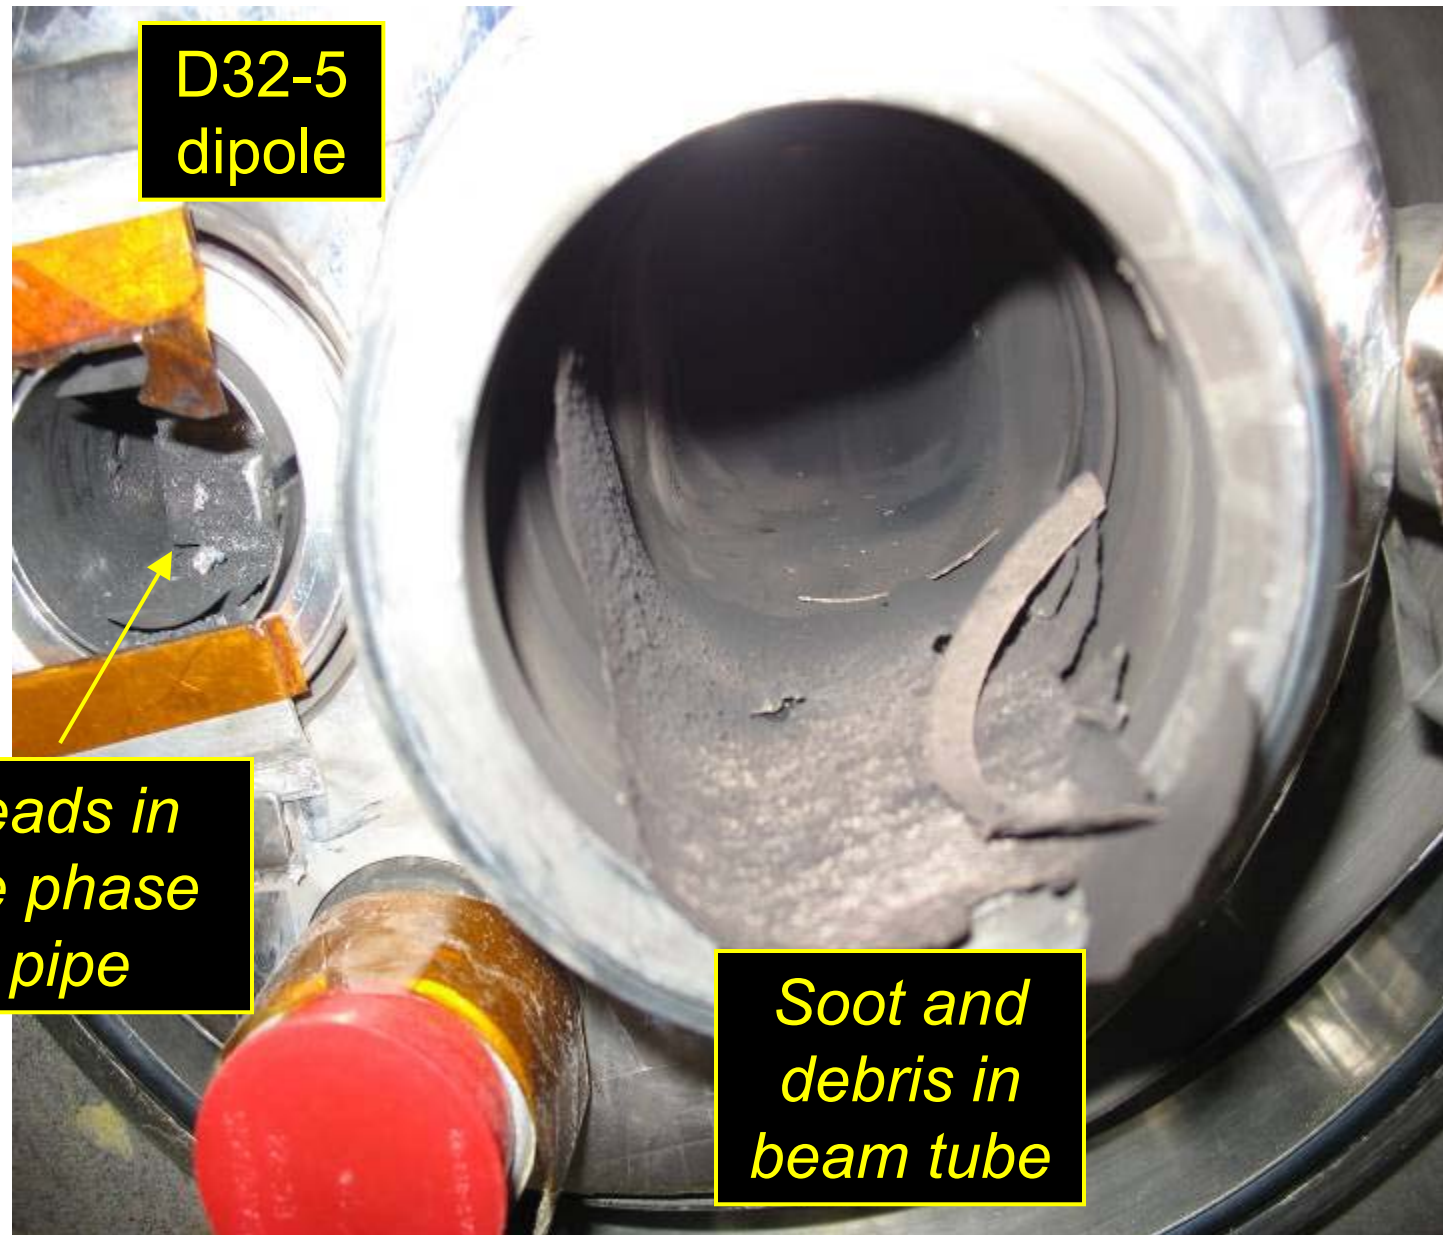
D32-5
dipole

No leads in
single phase
He pipe

Soot and
debris in
beam tube

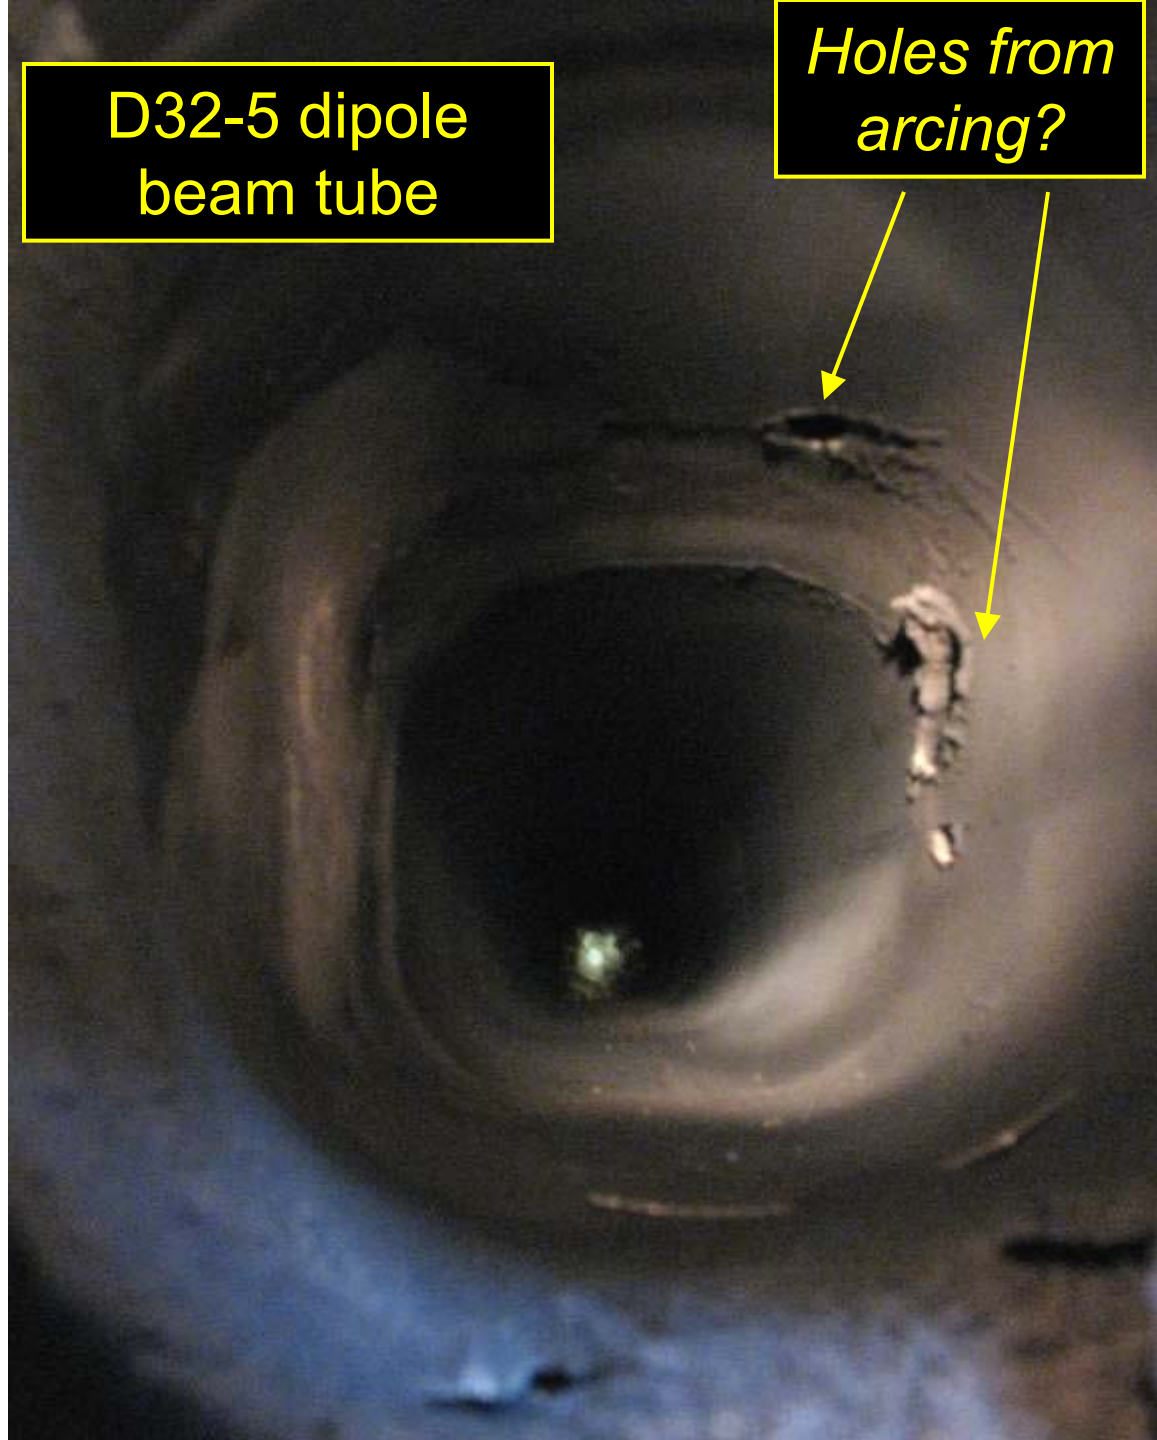
D32-5 dipole
beam tube

*Holes from
arcing?*
